**Flood Control Project Maintenance
Levee Inspections**
LMA District Cover Sheet
Spring 2017 Levee Inspection Results

Reclamation District No. 0404 Boggs

Spring 2017 Levee Inspection Results

Waterway			Bank	Unit Miles
Unit No. 01 San Joaquin River			Right	2.35
	Spring (March - May)	Summer (June - August)	(September - November) Fall	Winter (December - February)
Unit Maintenance Rating (Fall Only)				
Date of Inspection	4/6/2017 - 4/6/2017			
DWR Inspector	Richard Willoughby			
Accompanied By	Bob Winter KSN

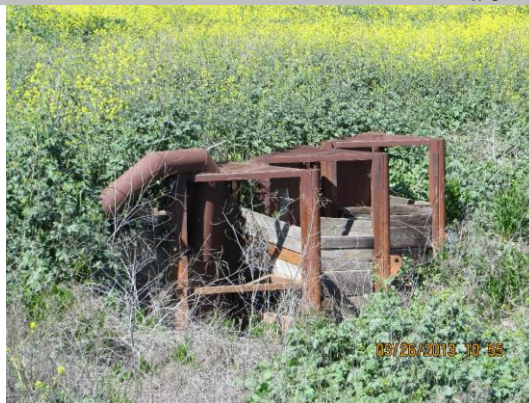
Photo 1 of 3 : UCIP_SP_2017_51168_20041.jpg

LM Start	0.65	Rating **	M	Issue No.	105
LM End	0.65	Issue Type +	En	Location *	CR
Category	Supplemental			GPS Latitude/Longitude	
				Start	End
Item	DWR UCIP Field Study			37.938670 °	37.938670 °
				-121.335397 °	-121.335397 °
DWR ID					
Comment Code					
Inspector Comment					
FS_ID:51168 DS_ID:17952 EP_NO: N/A Repair Type: Non-Urgent Crossing Status: Found UCIP Comments: Steel intake structure on landside of the levee. FIELD_STRUCT_DESC: 2 of 3: 30-inch corrugated metal drainage pipe through the levee, 22 feet below the crown. Flap gates on the waterside (WS) ends. Steel intake structure on the landside (LS). [Additional Reference(s): DWR Levee Log, 2006]. FS Date: 3/26/2013

LS- intake structure

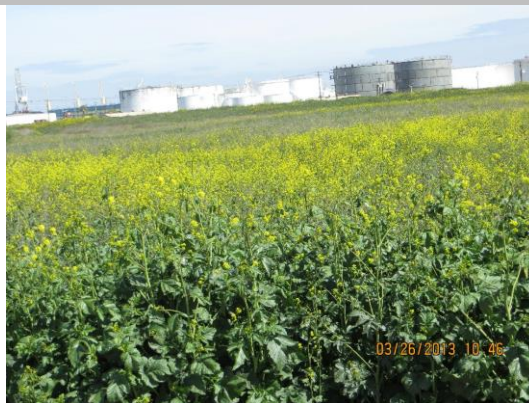
Photo 2 of 3 : UCIP_SP_2017_51168_20040.jpg

LS- overview of land side of the levee.

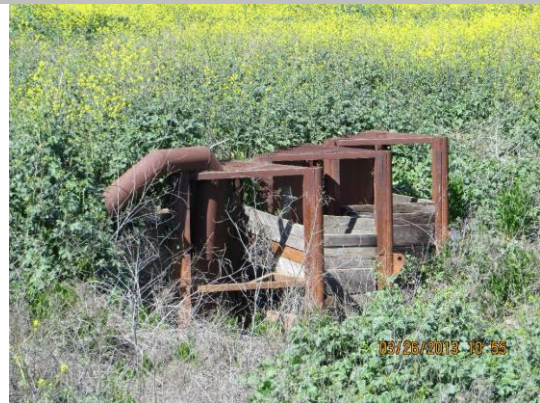
Photo 1 of 3 : UCIP_SP_2017_51166_20047.jpg

Comment Code					
Inspector Comment					
FS_ID:51166					
DS_ID:18811					
EP_NO: N/A					
Repair Type: Urgent					
Crossing Status: Found					
UCIP Comments: 12/13/2016 Since previous inspector and 2006 Levee Log cite damage to flap gate, I have upgraded this crossing from Non-Urgent to Urgent. Flap gates need to be in good working condition. (K. Fazel - UCIP)03/26/2013 Steel intake structure on LS. (P. Amatya - DWR)12/26/2006 Landward end filled with dirt. Middle flap gate missing and right flap gate broken as of 1/24/07. (DWR Levee Log)					
FIELD_STRUCT_DESC: 3 of 3: 30-inch corrugated metal drainage pipe through the levee, 22 feet below the crown. Flap gates on the waterside (WS) ends. Steel intake structure on the landside (LS). [Additional Reference(s): DWR Levee Log, 2006].					
FS Date: 3/26/2013

LS- steel intake structure

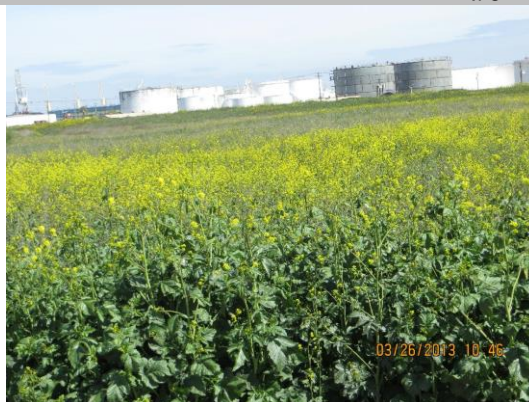
Photo 3 of 3 : UCIP_SP_2017_51166_20048.jpg

LS- overview of landside of the levee

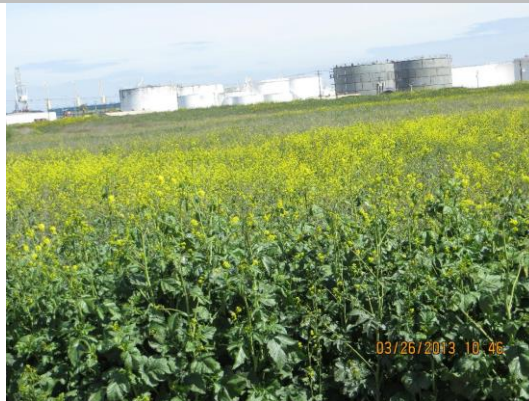
Photo 3 of 3 : UCIP_SP_2017_51167_20052.jpg

Comment Code					
Inspector Comment					
FS_ID:51167 DS_ID:18810 EP_NO: N/A Repair Type: Urgent Crossing Status: Found UCIP Comments: 12/13/2016 Since previous inspector and 2006 Levee Log cite damage to flap gate, I have upgraded this crossing from Non-Urgent to Urgent. Flap gates need to be in good working condition. (K. Fazel - UCIP)03/26/2013 Steel intake structure on LS. (P. Amatya - DWR)12/26/2006 Landward end filled with dirt. Middle flap gate missing and right flap gate broken as of 1/24/07. (DWR Levee Log) FIELD_STRUCT_DESC: 1 of 3: 30-inch corrugated metal drainage pipe through the levee, 22 feet below the crown. Flap gates on the waterside (WS) ends. Steel intake structure on the landside (LS). [Additional Reference(s): DWR Levee Log, 2006]. FS Date: 3/26/2013

LS- overview of landside of the levee.

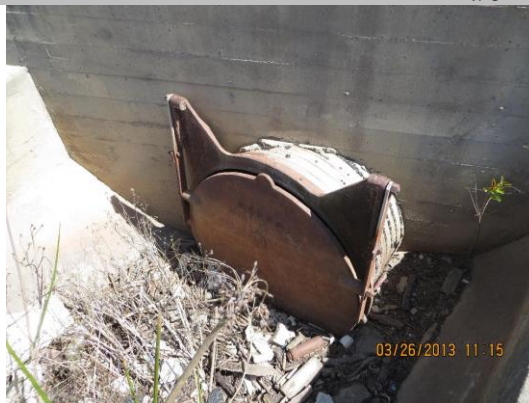
Photo 1 of 3 : UCIP_SP_2017_51169_19962.jpg

Comment Code					
Inspector Comment					
FS_ID:51169					
DS_ID:17945					
EP_NO: N/A					
Repair Type: Urgent					
Crossing Status: Found					
UCIP Comments: 11/29/2016 Flap gate still buried with sediment on WS. Requires clearing. (K. Fazel - UCIP)03/26/2013 Partially burried flap gate (P. Amatya - DWR)					
FIELD_STRUCT_DESC: 42-inch corrugated metal drainage pipe, 18 feet below the crown. Flap gate, concrete headwall and spillway on the waterside (WS). Pumphouse on the landside (LS). Abandoned concrete headwall, power pole, and two wooden piles found on the LS.					
[Additional Reference(s): DWR Levee Log, 2006. USACE San Joaquin O&M Manual 001, March 1963 (HLM 0.78)]. Pipe likely belongs to the City of Stockton.					
FS Date: 11/29/2016

WS- drainage outlet structure and CM pipe with flapgate

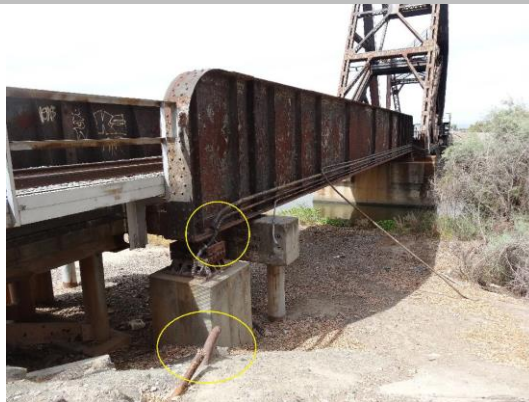
Photo 2 of 3 : UCIP_SP_2017_46810_74754.jpg

WS view looking west: conduits thru levee and attached to bridge

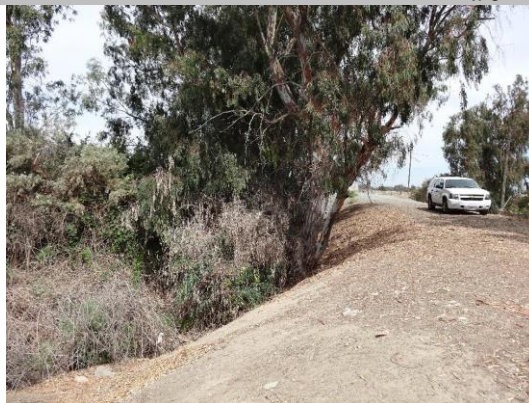
Photo 3 of 3 : UCIP_SP_2017_46810_74755.jpg

LM Start	0.79	Rating **	M	Issue No.	109 (cont)	
LM End	0.79	Issue Type +	En	Location *	LS	
Category	Supplemental			GPS Latitude/Longitude		
				Start		End
Item	DWR UCIP Field Study			37.937212 °		37.937212 °
				-121.333762 °		-121.333762 °
DWR ID						
Comment Code						
Inspector Comment						
FS_ID:46810 DS_ID:17946 EP_NO: N/A Repair Type: Non-Urgent Crossing Status: Found UCIP Comments: Appears abandoned; if so should be done so properly. FIELD_STRUCT_DESC: Underground telephone cable through levee and across channel. Non-operational. FS Date: 8/4/2015

WS view at crossing looking north

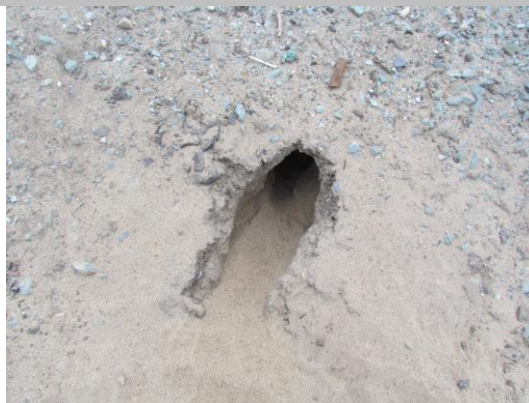
Photo 1 of 2 : SP_2017_RD0404_305_42_20170407_00070.jpg

LM Start	0.98	Rating **	U	Issue No.	42
LM End	0.98	Issue Type +	Ma	Location *	WS
Category	Earthen Levee			GPS Latitude/Longitude	
				Start	End
Item	Animal Control			37.935918 °	37.935918 °
				-121.331032 °	-121.331032 °
DWR ID	DWR_RD0404_01_s_2017_42				
Comment Code					
A3 : No rodents visible, but rodent burrows visible; need to backfill and compact or grout burrows.					
Inspector Comment

Looking west at large animal hole (den) on waterward shoulder.

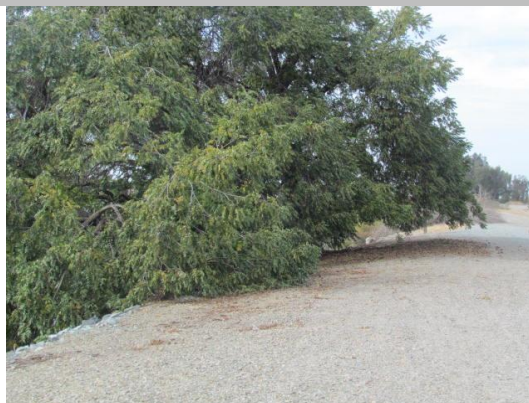
Photo 1 of 2 : SP_2017_RD0404_305_102_20170316_00032.jpg

LM Start	1.07	Rating **	A/W	Issue No.	102
LM End	1.07	Issue Type +	Ma	Location *	WS
Category	Earthen Levee			GPS Latitude/Longitude	
				Start	End
Item	Trim / Thin Trees			37.935358 °	37.935358 °
				-121.329645 °	-121.329645 °
DWR ID	DWR_RD0404_01_s_2012_102				
Comment Code					
T1 : Trim trees to at least five feet above ground level.					
Inspector Comment					
LMA corrected issue.

Looking northwest at untrimmed tree on waterward slope.

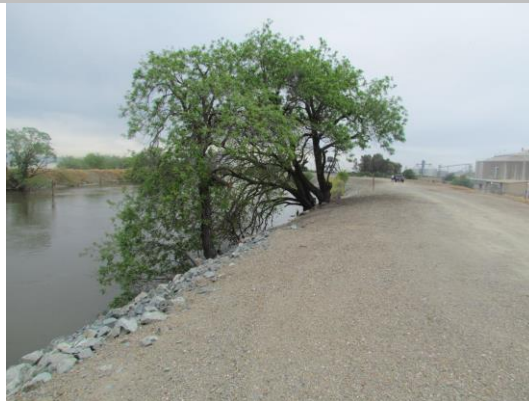
Photo 2 of 2 : SP_2017_RD0404_305_102_20170407_00072.jpg

Looking northwest at trimmed tree on waterward slope. (Spring 2017)

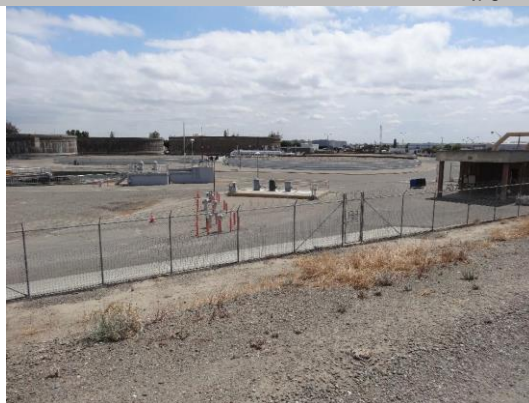
Photo 1 of 3 : UCIP_SP_2017_46801_74745.jpg

LM Start	1.09	Rating **	M	Issue No.	110
LM End	1.09	Issue Type +	En	Location *	WS
Category	Supplemental			GPS Latitude/Longitude	
				Start	End
Item	DWR UCIP Field Study			37.935195 °	37.935195 °
				-121.329398 °	-121.329398 °
DWR ID					
Comment Code					
Inspector Comment					
FS_ID:46801 DS_ID:25128 EP_NO: 1164 Repair Type: Non-Urgent Crossing Status: Indicator Found UCIP Comments: Conversation with WWTP engineer Ali Gharegozloo suggested this pipe has been welded shut. If so, mode of abandonment needs verification. FIELD_STRUCT_DESC: 60-inch reinforced concrete sewage pipe 27 FBC. Reinforced concrete apron and cut-off walls, steel sheet piling apron installed with pipe on WS slope. Headwall, stairs, pump with shutoff valve visible on WS slope. Apparent shut off valves 30 ft off LS toe in alignment with pipe. Permit No. 1164, 1947. FS Date: 7/9/2015

LS view: apparent shut off valves on WWTP property in alignment with 60-inch pipe.

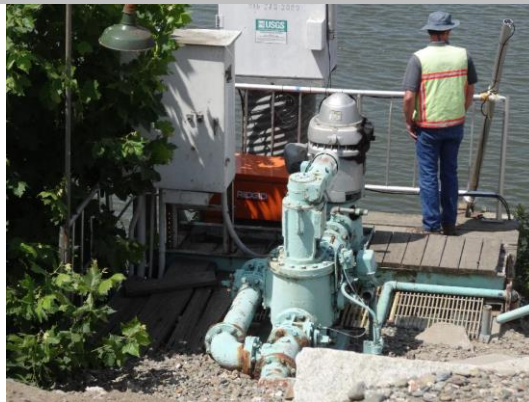
Photo 3 of 3 : UCIP_SP_2017_46801_74748.jpg

WS view: closeup of pump. CMP riser for USGS gage behind pump.

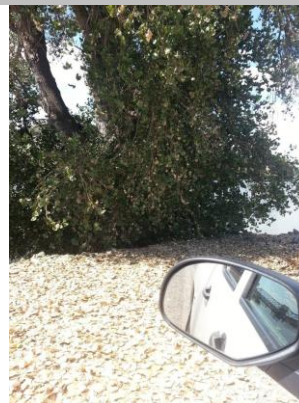
Photo 1 of 1 : SP_2017_RD0404_305_27_20170316_00015.jpg

LM Start	1.50	Rating **	A/W	Issue No.	27
LM End	1.50	Issue Type +	Ma	Location *	WS
Category	Earthen Levee			GPS Latitude/Longitude	
				Start	End
Item	Trim / Thin Trees			37.896544 °	37.896544 °
				-121.327121 °	-121.327121 °
DWR ID	DWR_RD0404_01_f_2016_27				
Comment Code					
T2 : Thin trees to allow visibility of the ground and room to flood fight.					
Inspector Comment

Looking west at untrimmed trees on waterward slope.

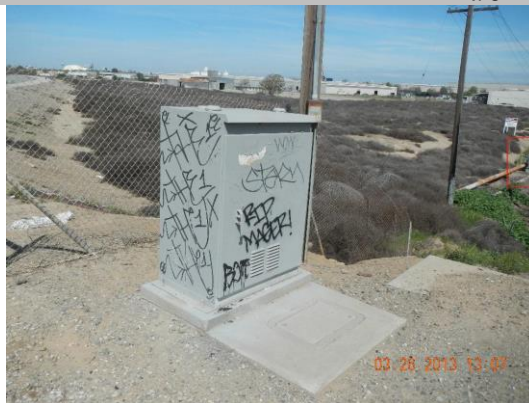
Photo 1 of 3 : UCIP_SP_2017_50763_20104.jpg

LM Start	1.55	Rating **	M	Issue No.	111
LM End	1.55	Issue Type +	En	Location *	CR
Category	Supplemental			GPS Latitude/Longitude	
				Start	End
Item	DWR UCIP Field Study			37.929046 °	37.929046 °
				-121.327248 °	-121.327248 °
DWR ID					
Comment Code					
Inspector Comment					
FS_ID:50763 DS_ID:18708 EP_NO: 4175 Repair Type: Non-Urgent Crossing Status: Found UCIP Comments: 11/17/2016 FPIIB Inspector Richard Willoughby noted 3-4 inch depression over pipes on crown, an indication of possible pipe collapse. (K. Fazel - UCIP) FIELD_STRUCT_DESC: 1 of 2. 12-inch-diameter steel pipes through levee, 5.0 feet below the crown. Siphon breakers on the waterward shoulder. Pump and electric control panel/pole on landside approximately 200 ft from levee. (Permit No. 4175-1963) FS Date: 11/17/2016

LS- overview of pipe and pump (far right)

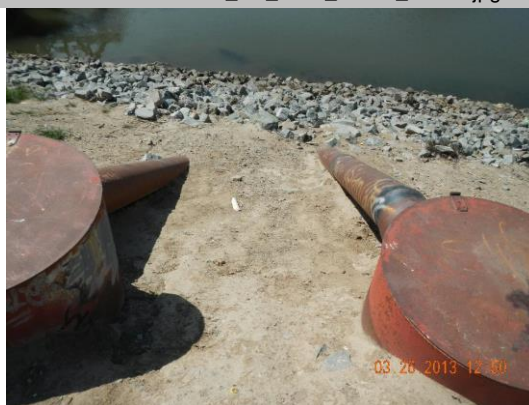
Photo 2 of 3 : UCIP_SP_2017_50763_20103.jpg

WS- steel pipes and siphon breakers in steel pipe risers.

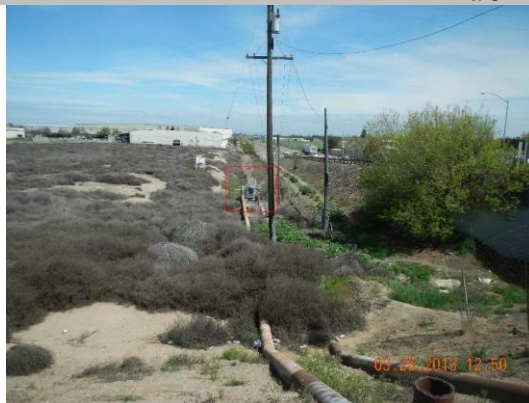
Photo 3 of 3 : UCIP_SP_2017_50763_20102.jpg

LS- pipes and pumps (center)

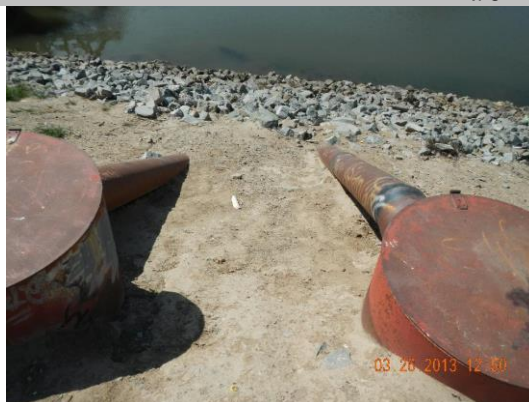
Photo 1 of 3 : UCIP_SP_2017_50764_19994.jpg

LM Start	1.55	Rating **	M	Issue No.	112
LM End	1.55	Issue Type +	En	Location *	CR
Category	Supplemental			GPS Latitude/Longitude	
				Start	End
Item	DWR UCIP Field Study			37.929046 °	37.929046 °
				-121.327248 °	-121.327248 °
DWR ID					
Comment Code					
Inspector Comment					
FS_ID:50764 DS_ID:17955 EP_NO: 4175 Repair Type: Non-Urgent Crossing Status: Found UCIP Comments: 11/17/2016 FPIIB Inspector Richard Willoughby noted 3-4 inch dip in crown over pipes, an indication of possible pipe collapse. (K. Fazel - UCIP) FIELD_STRUCT_DESC: 2 of 2. 12-inch-diameter pipes through levee, 5.0 feet below the crown. Siphon breakers on the waterward shoulder. Power pole, electric control panel and pump about 200 ft from the levee on landside. (Permit No. 4175-1963) FS Date: 11/17/2016

WS- steel pipes and siphon breakers in steel pipe risers.

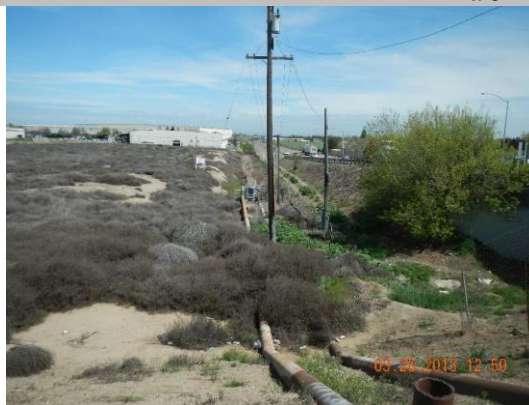
Photo 3 of 3 : UCIP_SP_2017_50764_19995.jpg

LS- pipes and pumps on center.

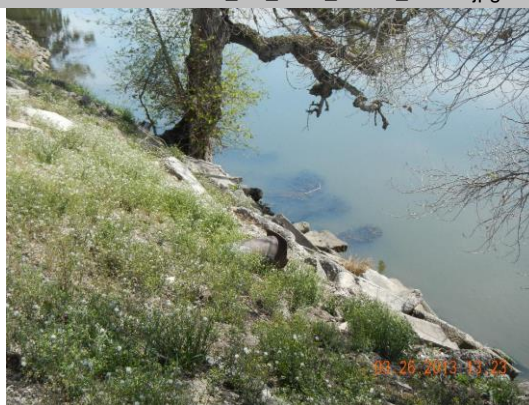
Photo 1 of 3 : UCIP_SP_2017_40487_20064.jpg

LM Start	1.64	Rating **	M	Issue No.	114
LM End	1.64	Issue Type +	En	Location *	WS
Category	Supplemental			GPS Latitude/Longitude	
				Start	End
Item	DWR UCIP Field Study			37.928090 °	37.928090 °
				-121.326215 °	-121.326215 °
DWR ID					
Comment Code					
Inspector Comment					
FS_ID:40487 DS_ID:18812 EP_NO: 10897 Repair Type: Non-Urgent Crossing Status: Found UCIP Comments: Abandoned crossing. WS pipe capped with steel pipe and LS pipe cut. FIELD_STRUCT_DESC: Abandoned 14-inch irrigation pipe. 3.0 feet below levee crown (Permit No. 10897). FS Date: 3/26/2013

WS- steel pipe capped with steel plate.

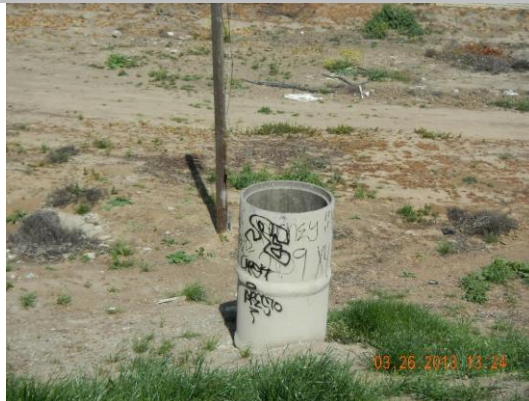
Photo 2 of 3 : UCIP_SP_2017_40487_20063.jpg

LS- concrete standpipe on levee slope

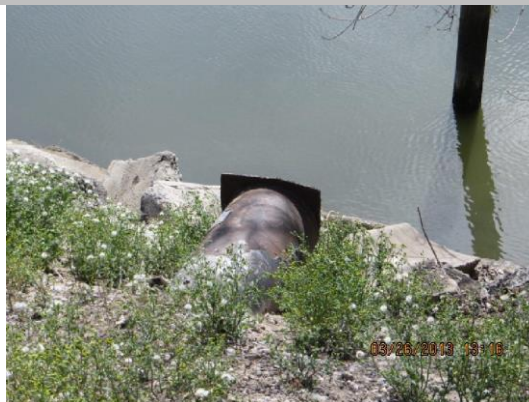
Photo 3 of 3 : UCIP_SP_2017_40487_20065.jpg

WS- abandoned steel pipe capped with steel plate.

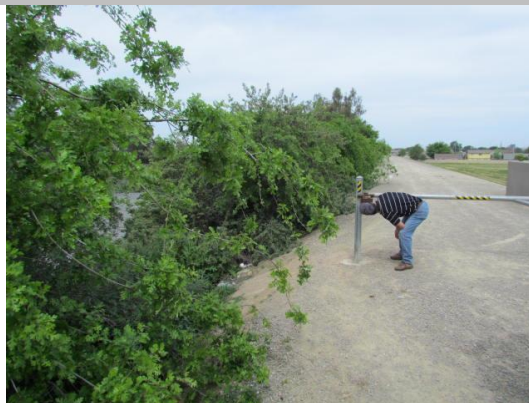
Photo 1 of 2 : SP_2017_RD0404_305_29_20170316_00018.jpg

LM Start	1.70	Rating **	A/W	Issue No.	29
LM End	1.77	Issue Type +	Ma	Location *	WS
Category	Earthen Levee			GPS Latitude/Longitude	
				Start	End
Item	Trim / Thin Trees			37.927517 °	37.926632 °
				-121.325515 °	-121.324868 °
DWR ID	DWR_RD0404_01_s_2015_29				
Comment Code					
T1 : Trim trees to at least five feet above ground level.					
Inspector Comment					
Dense untrimmed trees on waterward slope. Army Corp veg site.Tree and woody vegetation planted by the DWR but not being maintain according to agreement.

Looking north at dense vegetation on waterward slope.

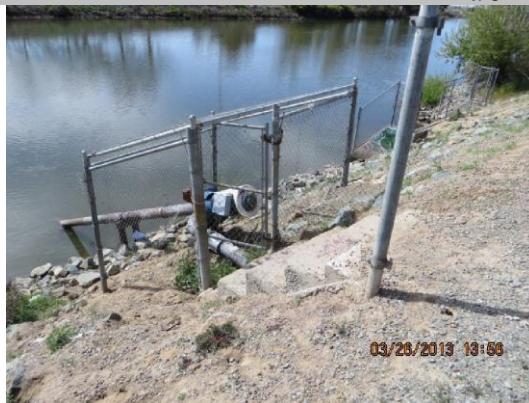
Photo 1 of 3 : UCIP_SP_2017_40797_20073.jpg

FS_ID:40797
DS_ID:17961
EP_NO: 6560
Repair Type: Non-Urgent
Crossing Status: Found
UCIP Comments: Damaged siphon breaker in pipe riser near the landward shoulder.
FIELD_STRUCT_DESC: 8-inch pipe through the levee, 7.0 feet below the crown, chain link fence around pump and motor on the waterward slope. (Permit. No. 6560)
FS Date: 3/26/2013

WS- slanted pump, pipe, and concrete steps on levee slope.

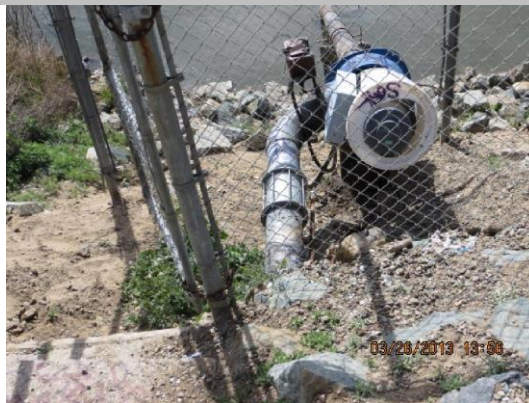
Photo 2 of 3 : UCIP_SP_2017_40797_20072.jpg

WS- slanted pump, and pipe on levee slope.

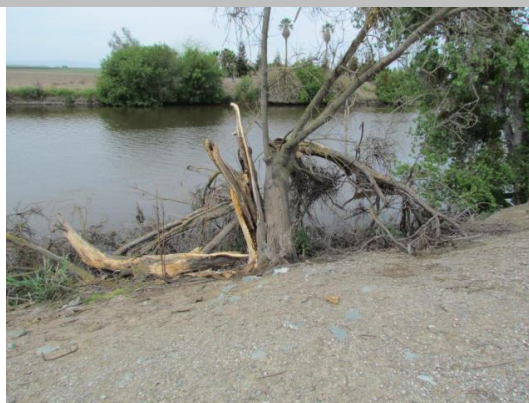
Photo 1 of 1 : SP_2017_RD0404_305_33_20170316_00023.jpg

LM Start	2.00	Rating **	U	Issue No.	33
LM End	2.00	Issue Type +	Ma	Location *	WS
Category	Earthen Levee			GPS Latitude/Longitude	
				Start	End
Item	Encroachments			37.923673 °	37.923673 °
				-121.323015 °	-121.323015 °
DWR ID	DWR_RD0404_01_s_2016_33				
Comment Code					
TR : Tree or limb					
Inspector Comment					
Dead tree on waterward slope

Looking west at dead tree on waterward slope.

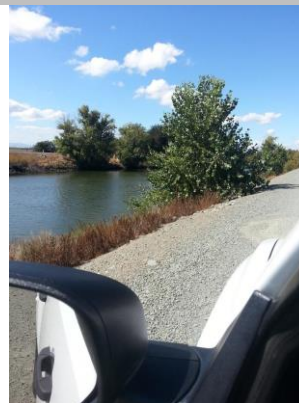
Photo 1 of 1 : SP_2017_RD0404_305_13_20170316_00010.jpg

LM Start	2.08	Rating **	A/W	Issue No.	13
LM End	2.08	Issue Type +	Ma	Location *	WS
Category	Earthen Levee			GPS Latitude/Longitude	
				Start	End
Item	Trim / Thin Trees			37.922669 °	37.922669 °
				-121.322272 °	-121.322272 °
DWR ID	DWR_RD0404_01_f_2012_13				
Comment Code					
T1 : Trim trees to at least five feet above ground level.					
Inspector Comment

Looking northwest at untrimmed tree on waterward slope.

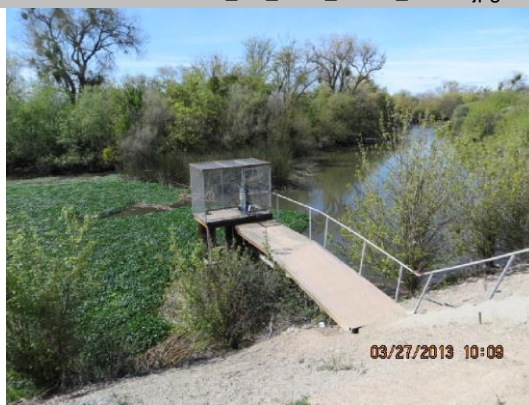
Photo 1 of 3 : UCIP_SP_2017_10908_18182.jpg

LM Start	0.73	Rating **	M	Issue No.	68
LM End	0.73	Issue Type +	En	Location *	LS
Category	Supplemental			GPS Latitude/Longitude	
				Start	End
Item	DWR UCIP Field Study			37.919336 °	37.919336 °
				-121.306782 °	-121.306782 °
DWR ID					
Comment Code					
Inspector Comment					
FS_ID:10908					
DS_ID:18781					
EP_NO: 3340A					
Repair Type: Non-Urgent					
Crossing Status: Found					
UCIP Comments: - Not working for 5 years- Golf club staff- Wooden					
Walkway; Concrete steps- Damaged siphon breaker					
FIELD_STRUCT_DESC: 6-inch pipe through the levee, 2.0 feet below					
the crown. Pump on pile structure in stream. Shut-off valve and siphon					
breaker on the waterward shoulder. Timber walkway on the waterward					
slope. One CM cutoff wall. (Permit No. 3340A)					
FS Date: 3/27/2013

WS- pump on steel structure and wooden walkway

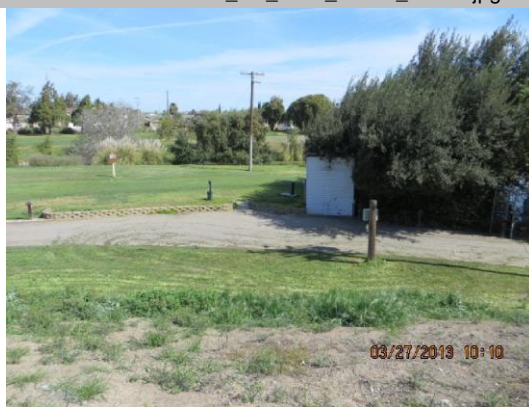
Photo 3 of 3 : UCIP_SP_2017_10908_18180.jpg

LS- overview of LS slope

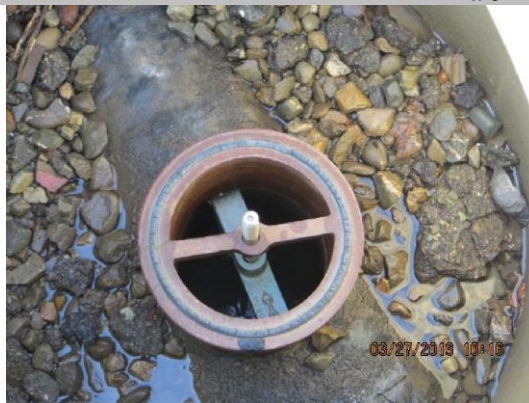
Photo 1 of 3 : UCIP_SP_2017_10945_18248.jpg

FS_ID:10945
DS_ID:18782
EP_NO: 4448
Repair Type: Non-Urgent
Crossing Status: Found
UCIP Comments: Concrete stairway on waterward slope- Not found.
Pump was working during field survey. Siphon breaker cap missing.
FIELD_STRUCT_DESC: 18-inch pipe through the levee, 9.3 feet below the crown, pump on the landward side. Siphon breaker in concrete well on the waterward shoulder. Two CM cutoff walls. (Permit No. 4448)
FS Date: 3/27/2013

WS- siphon breaker without cap in concrete riser

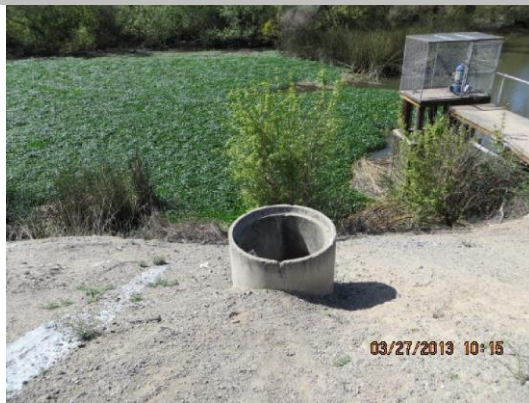
Photo 2 of 3 : UCIP_SP_2017_10945_18247.jpg

WS- concrete riser on steep levee slope

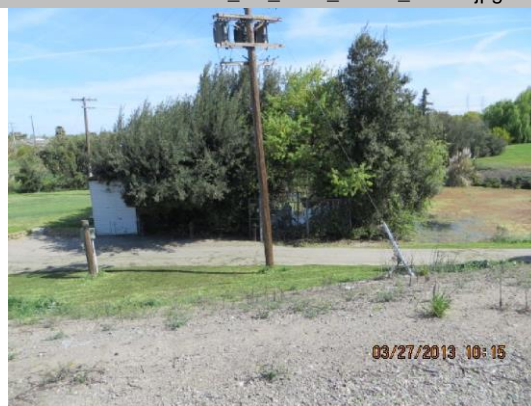
Photo 3 of 3 : UCIP_SP_2017_10945_18250.jpg

LS- overview of pumping plant and levee slope

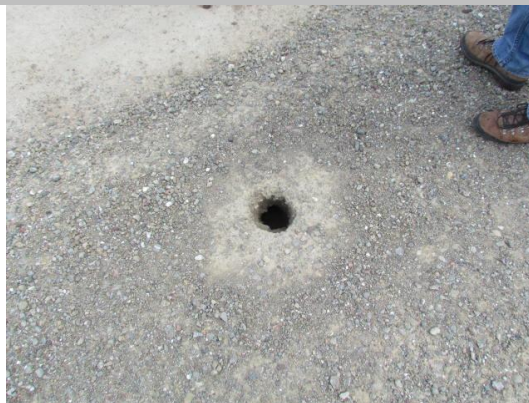
Photo 2 of 3 : SP_2017_RD0404_306_20_20170316_00007.jpg

LM Start	1.08	Rating **	U	Issue No.	20 (cont)	
LM End	1.08	Issue Type +	Ma	Location *	LS	
Category	Earthen Levee			GPS Latitude/Longitude		
				Start		End
Item	Animal Control			37.916383 °		37.916383 °
				-121.302802 °		-121.302802 °
DWR ID	DWR_RD0404_02_s_2016_20					
Comment Code						
A3 : No rodents visible, but rodent burrows visible; need to backfill and compact or grout burrows.						
Inspector Comment						
Large rodent holes on landward slope and levee crown.

Looking at rodent hole on levee crown.

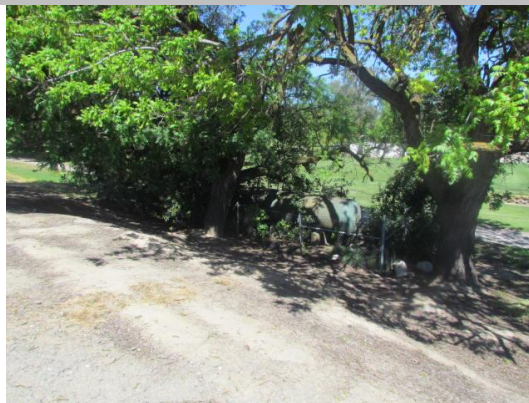
Photo 2 of 4 : SP_2017_RD0404_306_67_20170316_00012.jpg

Looking north at dense vegetation on landward toe around propane tank.

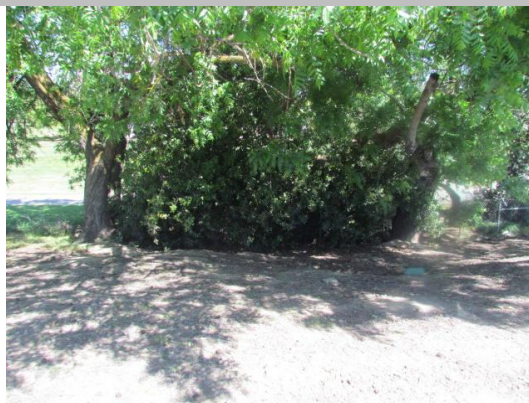
Photo 3 of 4 : SP_2017_RD0404_306_67_20170316_00013.jpg

Looking northeast at dense vegetation on landward toe. (Spring 2013)

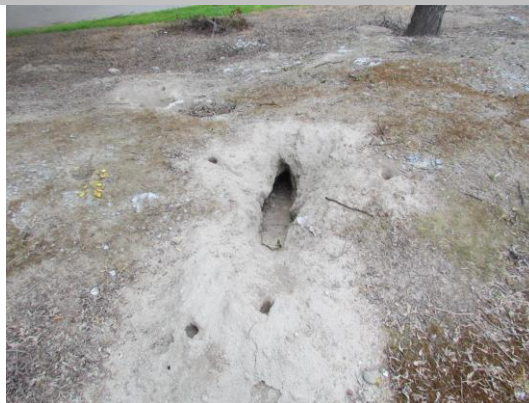
Photo 1 of 2 : SP_2017_RD0404_306_22_20170407_00032.jpg

LM Start	1.18	Rating **	M	Issue No.	22
LM End	1.18	Issue Type +	Ma	Location *	LS
Category	Earthen Levee			GPS Latitude/Longitude	
				Start	End
Item	Animal Control			37.916483 °	37.916483 °
				-121.301100 °	-121.301100 °
DWR ID	DWR_RD0404_02_s_2017_22				
Comment Code					
A3 : No rodents visible, but rodent burrows visible; need to backfill and compact or grout burrows.					
Inspector Comment

Looking east at large rodent hole on landward slope.

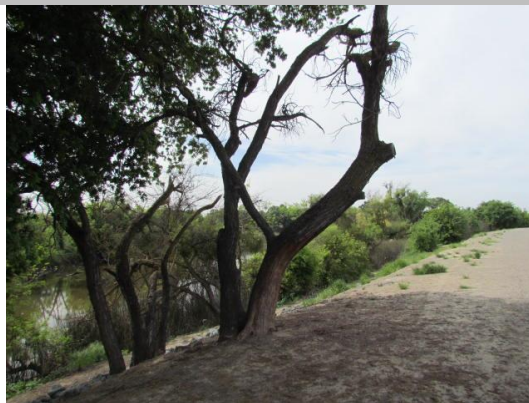
Photo 1 of 2 : SP_2017_RD0404_306_18_20170316_00005.jpg

LM Start	1.24	Rating **	U	Issue No.	18
LM End	1.24	Issue Type +	Ma	Location *	WS
Category	Earthen Levee			GPS Latitude/Longitude	
				Start	End
Item	Encroachments			37.917092 °	37.917092 °
				-121.300352 °	-121.300352 °
DWR ID	DWR_RD0404_02_s_2016_18				
Comment Code					
TR : Tree or limb					
Inspector Comment					
Remove dead tree from waterward slope.

Looking east at dead trees on waterward slope.

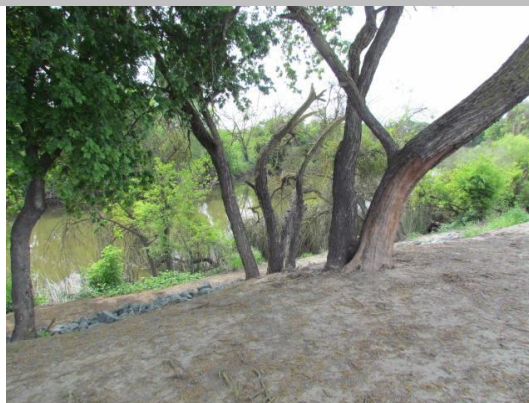
Photo 2 of 2 : SP_2017_RD0404_306_18_20170316_00006.jpg

Looking at close up view of dead trees on waterward slope.

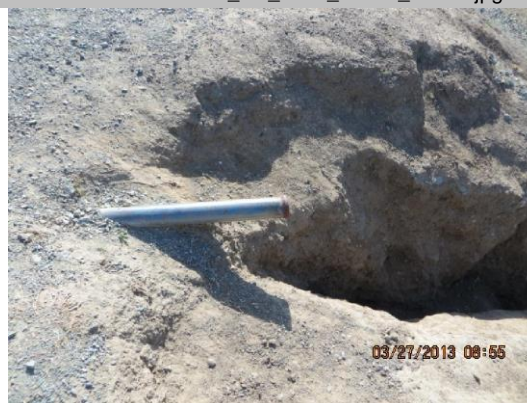
Photo 1 of 3 : UCIP_SP_2017_51171_18134.jpg

Comment Code					
Inspector Comment					
FS_ID:51171 DS_ID:18792 EP_NO: 3340 Repair Type: Non-Urgent Crossing Status: Indicator Found UCIP Comments: 11/29/2016 Pipe was not found. As per DWR Inspector Richard Willoughby, pipe was removed by City without a permit. Erosion cited previously has been backfilled. Backfill material on WS is redder in color than original material, indicating a recent backfill. Crossing has been downgraded from Urgent to Non-Urgent since no permit issued for this work. (K. Fazel - UCIP)03/27/2013 Abandoned and capped 3-in GI pipe found on WS. Damaged air-valve/siphon breaker found on LS.Gully formed due to leaky pipe. A pump house found on LS but it needs to be verified by LMA whether this is associated with this crossing. (P. Amatya - DWR) FIELD_STRUCT_DESC: *REMOVED* 3-inch galvanized iron (GI) pipe through the levee, 1 foot below the crown. Pile structure in the stream. Damaged siphon breaker at the landside (LS) toe. (Permit No. 3340, 1960 - City of Stockton) FS Date: 11/29/2016

WS- capped 3-inch GI pipe

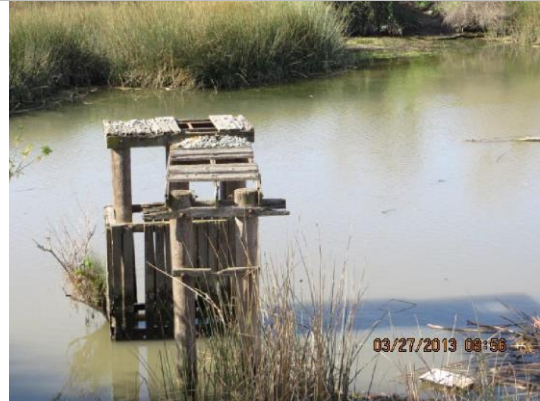
Photo 3 of 3 : UCIP_SP_2017_51171_18132.jpg

WS- abandoned pump station.

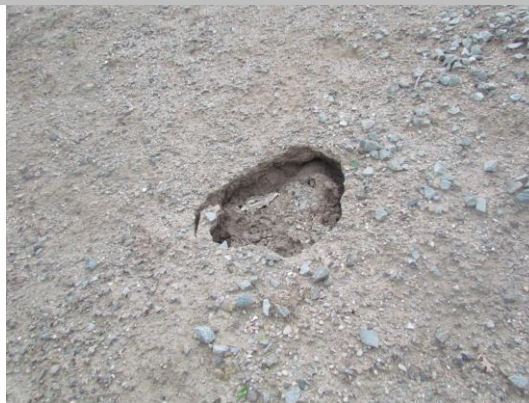
Photo 1 of 2 : SP_2017_RD0404_306_19_20170407_00034.jpg

LM Start	1.65	Rating **	U	Issue No.	19
LM End	1.65	Issue Type +	Ma	Location *	WS
Category	Earthen Levee			GPS Latitude/Longitude	
				Start	End
Item	Erosion / Bank Caving			37.917860 °	37.917860 °
				-121.293530 °	-121.293530 °
DWR ID	DWR_RD0404_02_s_2017_19				
Comment Code					
E2 : Schedule repair of erosion site prior to the next inspection.					
Inspector Comment					
Several sinkholes near toe of levee

Looking north at one of several sink holes at waterward toe.

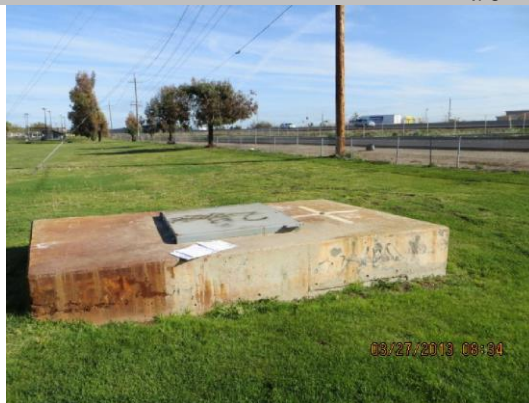
Photo 1 of 3 : UCIP_SP_2017_10846_18127.jpg

LM Start	1.76	Rating **	M	Issue No.	72
LM End	1.76	Issue Type +	En	Location *	WS
Category	Supplemental			GPS Latitude/Longitude	
				Start	End
Item	DWR UCIP Field Study			37.917284 °	37.917284 °
				-121.291740 °	-121.291740 °
DWR ID					
Comment Code					
Inspector Comment					
FS_ID:10846 DS_ID:18804 EP_NO: N/A Repair Type: Non-Urgent Crossing Status: Indicator Found UCIP Comments: Only a 7 ft x 14 ft concrete vault found on LS.Needs a sign post.Bob Winter from KSN(representative of RD 404) will investigate on this crossing. FIELD_STRUCT_DESC: 1 of 2. 42-inch-diameter pipelines under the levee. Pipes cross under the channel. FS Date: 3/27/2013

LS- 7' x 14' concrete vault.

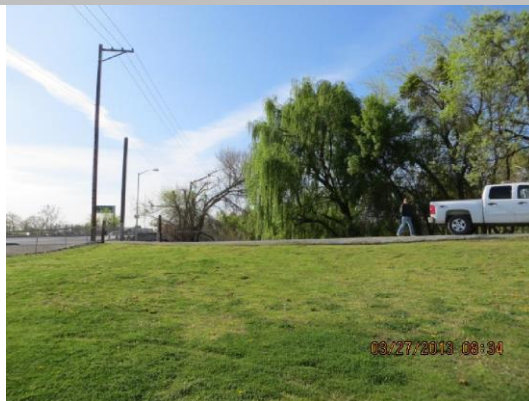
Photo 2 of 3 : UCIP_SP_2017_10846_18126.jpg

Crown view of the levee.

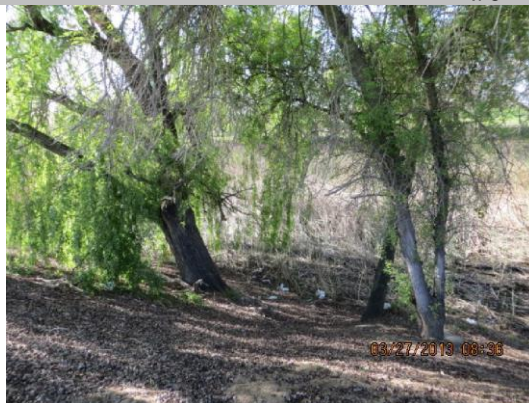
Photo 3 of 3 : UCIP_SP_2017_10846_18128.jpg

WS- no pipes found.

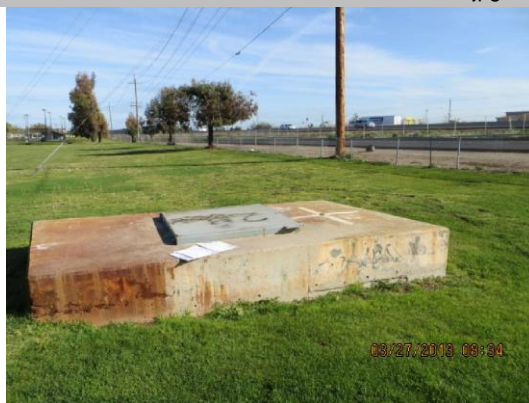
Photo 1 of 3 : UCIP_SP_2017_12426_20130.jpg

LM Start	1.76	Rating **	M	Issue No.	73
LM End	1.76	Issue Type +	En	Location *	WS
Category	Supplemental			GPS Latitude/Longitude	
				Start	End
Item	DWR UCIP Field Study			37.917284 °	37.917284 °
				-121.291740 °	-121.291740 °
DWR ID					
Comment Code					
Inspector Comment					
FS_ID:12426 DS_ID:18787 EP_NO: N/A Repair Type: Non-Urgent Crossing Status: Indicator Found UCIP Comments: Only a 7 ft x 14 ft concrete vault found on LS.Needs a sign post.Bob Winter from KSN(representative of RD 404) will investigate on this crossing. FIELD_STRUCT_DESC: 2 of 2. 42-inch-diameter pipelines under the levee. Pipes cross under the channel. FS Date: 3/27/2013

LS- 7' x 14' concrete vault.

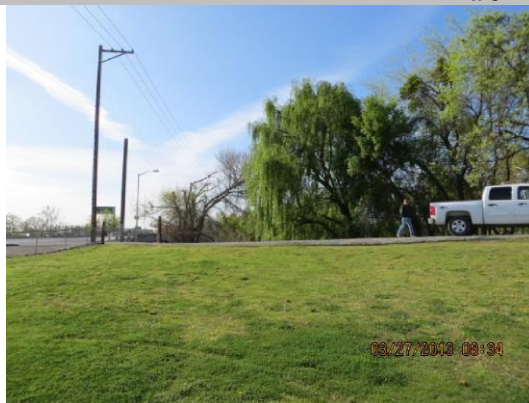
Photo 2 of 3 : UCIP_SP_2017_12426_20129.jpg

Crown view of the levee.

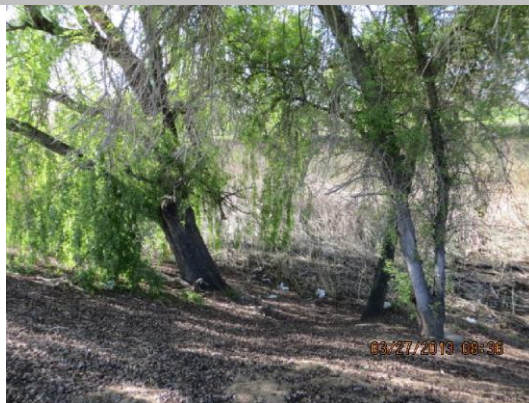
Photo 3 of 3 : UCIP_SP_2017_12426_20131.jpg

WS- no pipes found.
